**RE: UST Closure Report
Motiva Enterprises LLC – Fayetteville Bulk Terminal
1274 Shaw Mill Road
Fayetteville, Cumberland County, North Carolina
Facility ID # 00-0-0000011481**

UST CLOSURE REPORT - 2016

**Fayetteville Bulk Terminal
1274 Shaw Mill Road
Fayetteville, Cumberland County, North Carolina 28311
Facility ID – 00-0-0000011481**

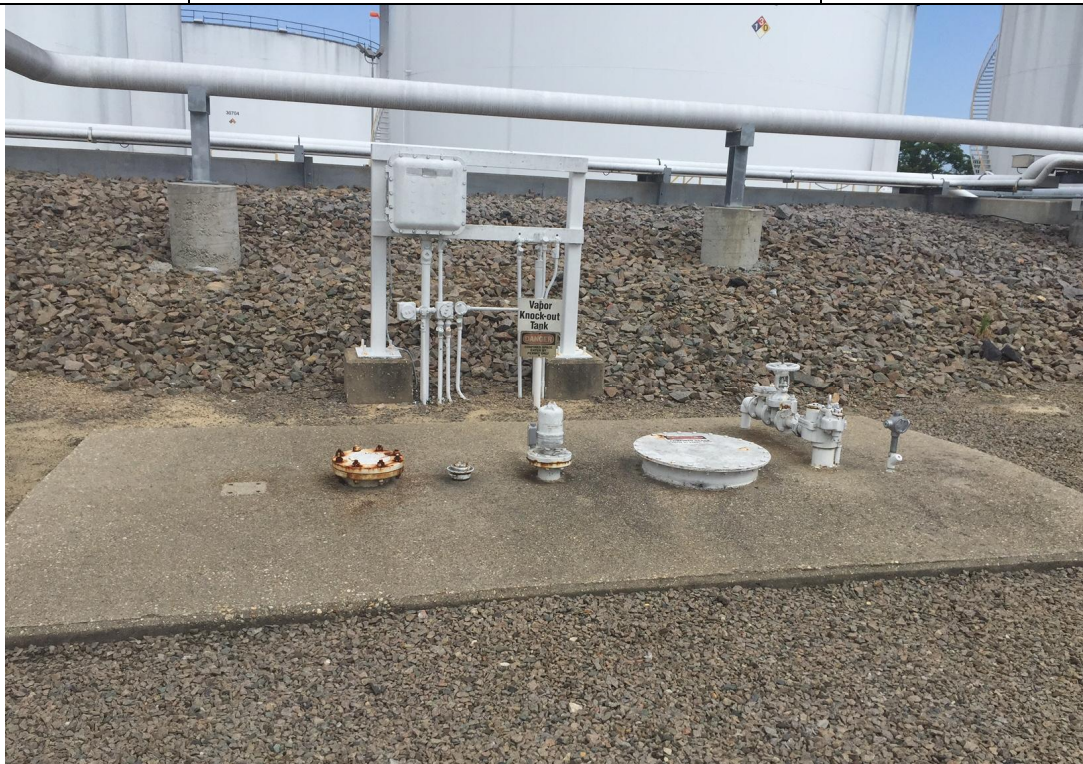
Photo No.
1

Vapor knockout UST prior to abandonment activities (AST farm in background).

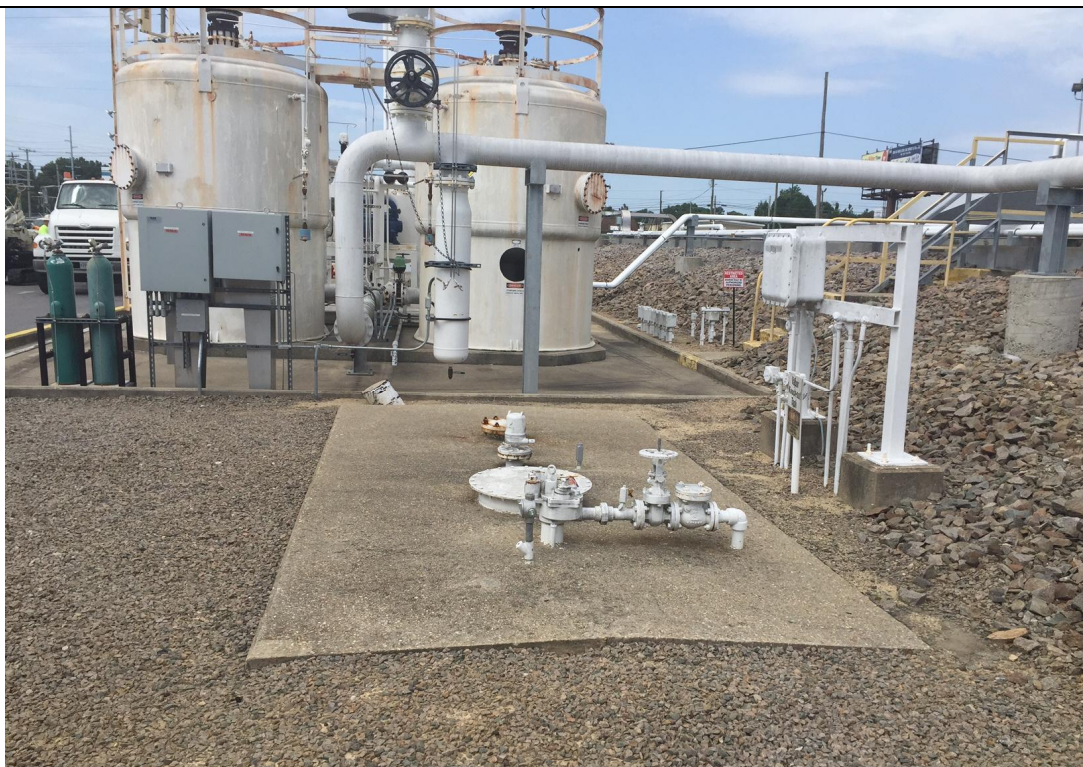
Photo No.
2

Vapor knockout UST prior to abandonment activities.

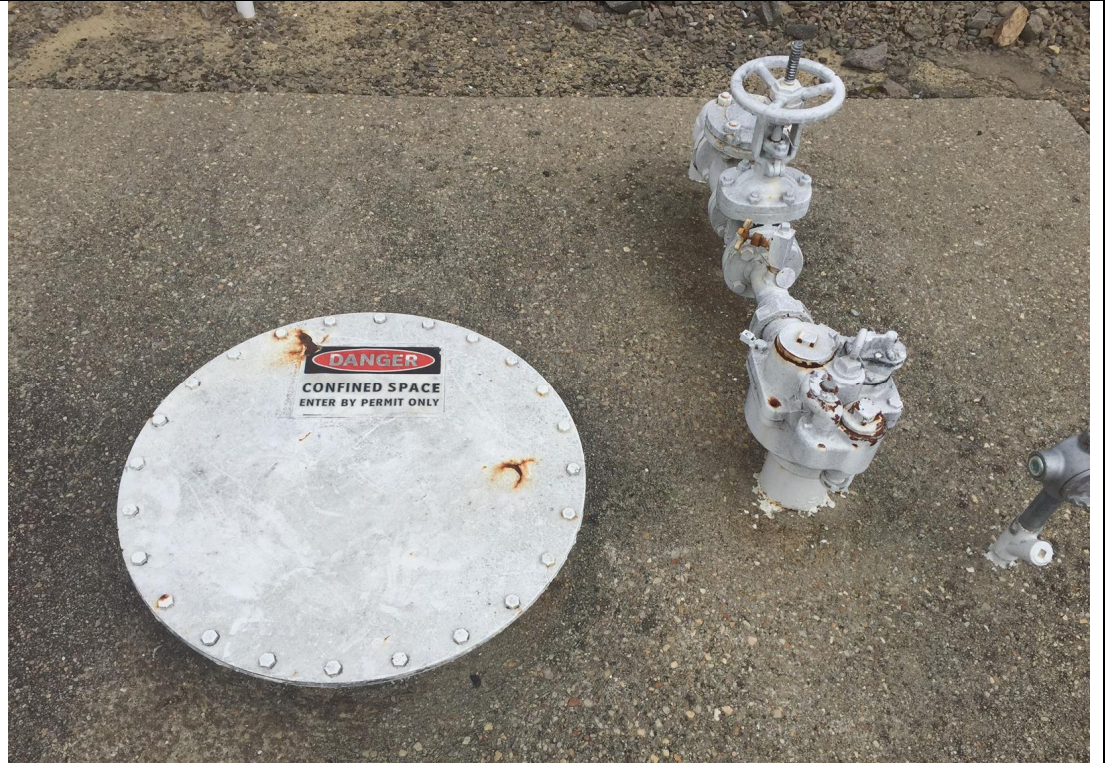
24-inch manhole access of vapor knockout UST prior to abandonment activities.

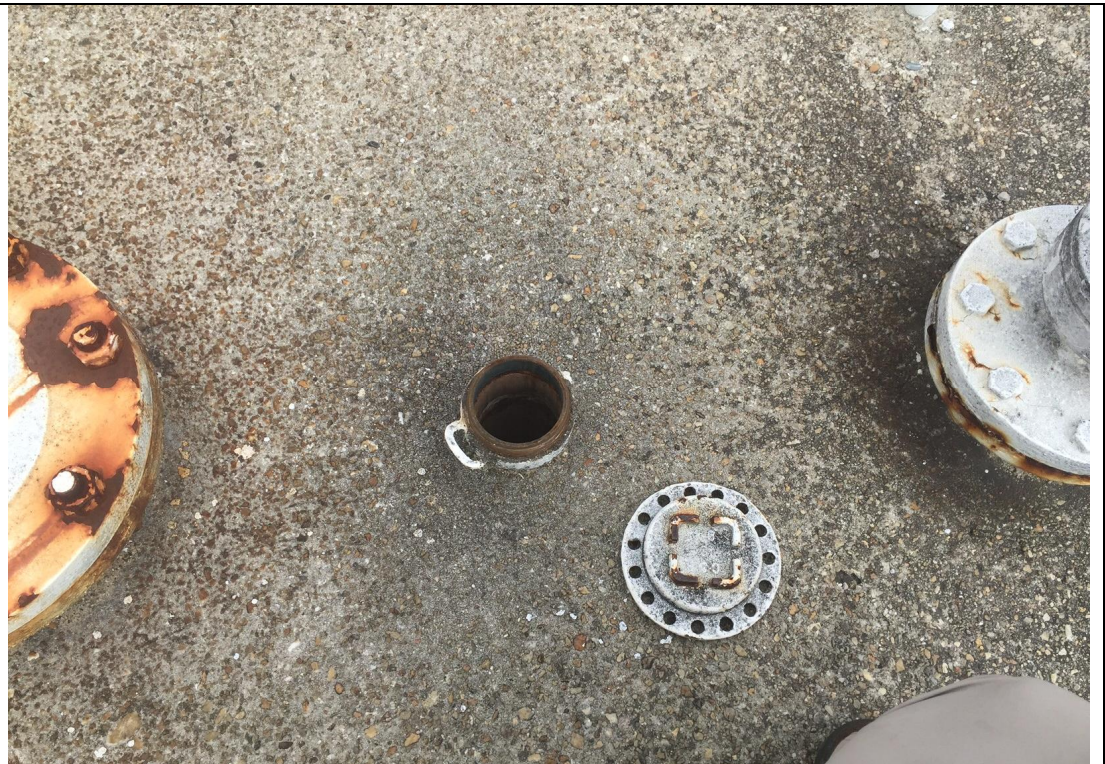
Photo No.
4

2.5-inch measurement port of vapor knockout UST prior to abandonment activities.

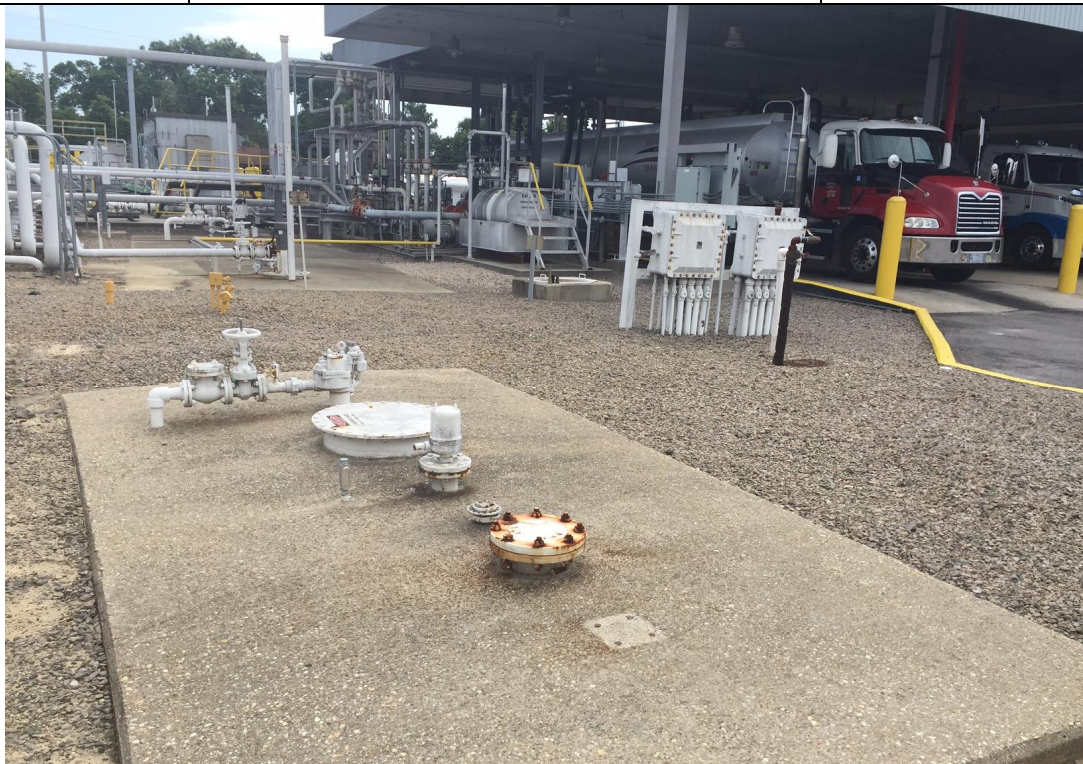
Vapor Knockout UST
prior to abandonment
activities (loading rack in
background).

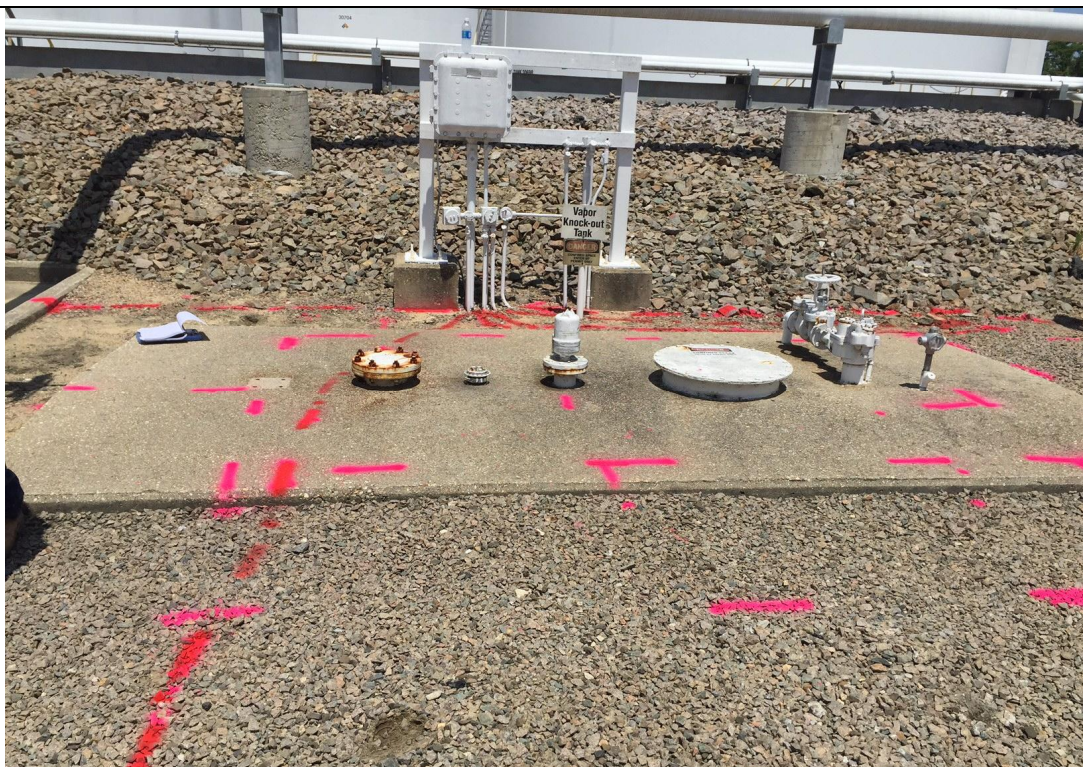
Photo No.
6

Underground
piping/utility mark out.

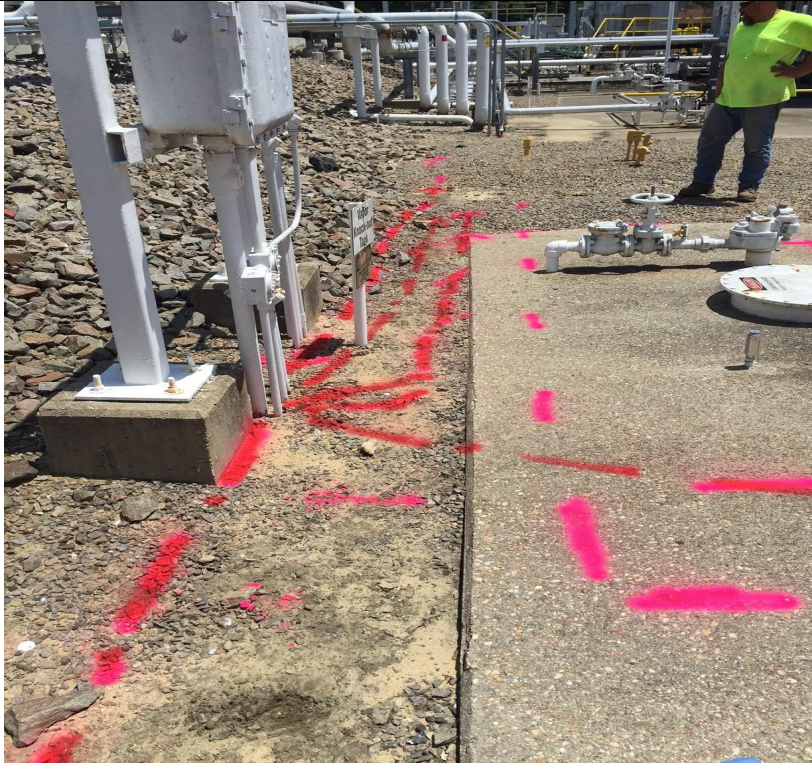
Crowded underground piping behind Vapor Knockout UST.

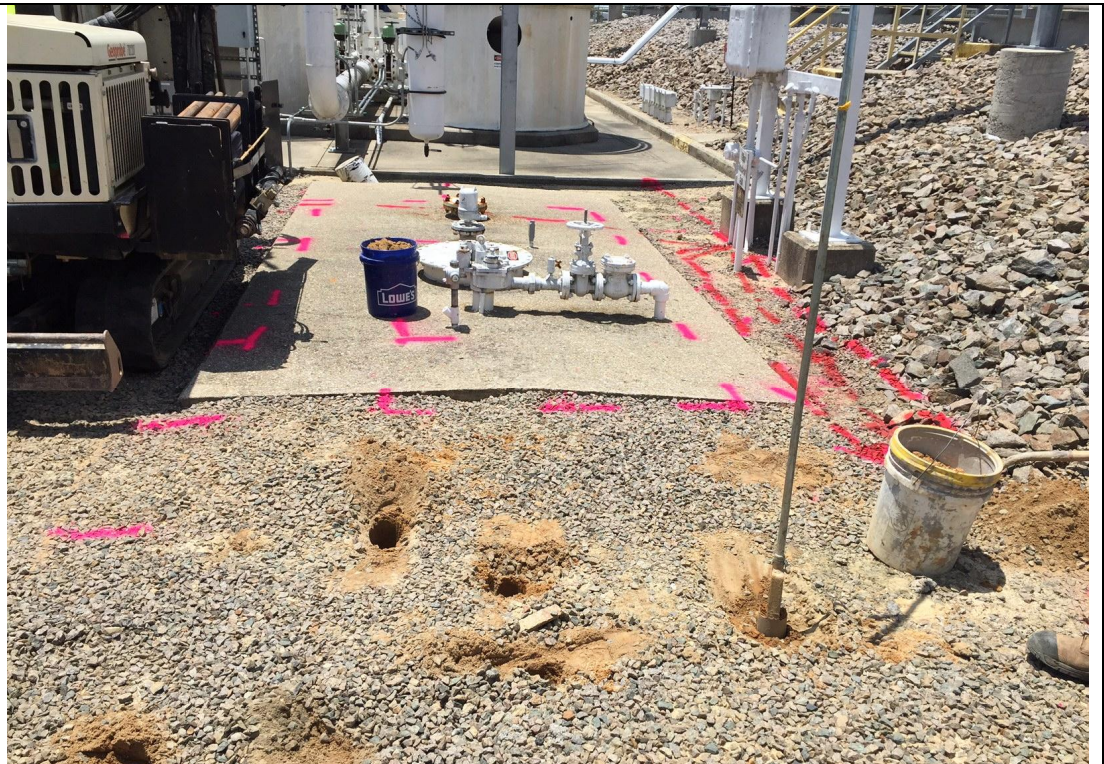
Photo No.
8

Refusal encountered at approximately 3.5 to 5 feet below ground surface at multiple locations northeast of UST.

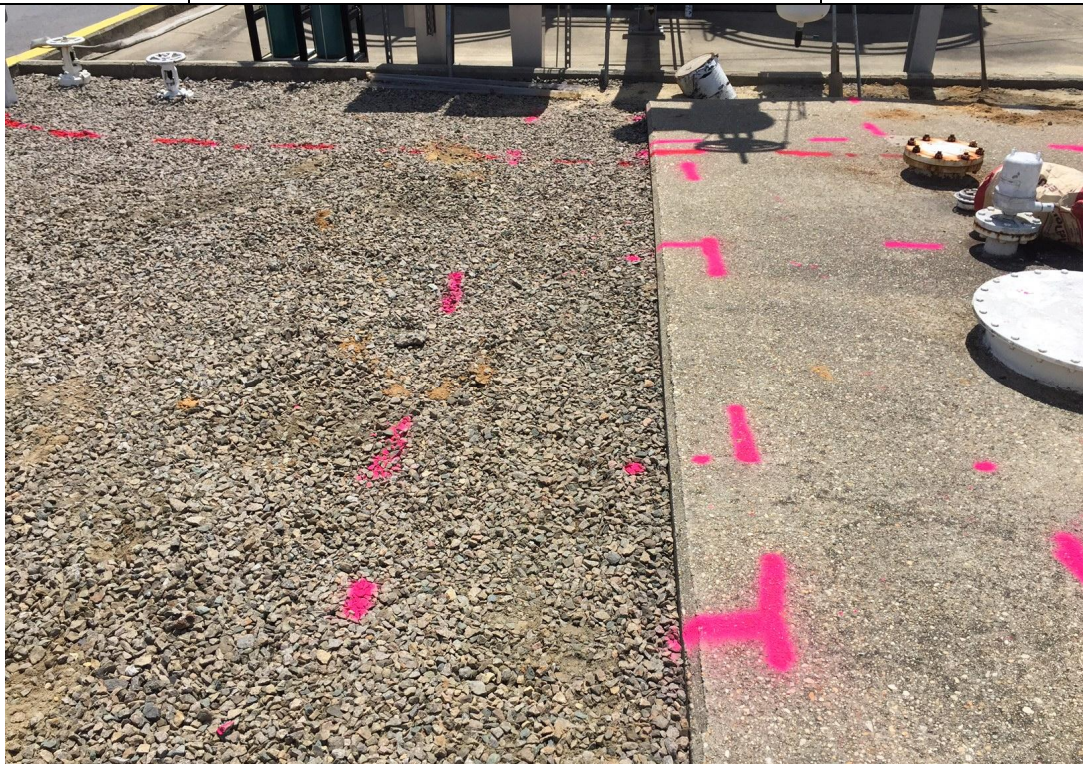
Area surrounding Vapor Knockout UST following soil sampling activities.

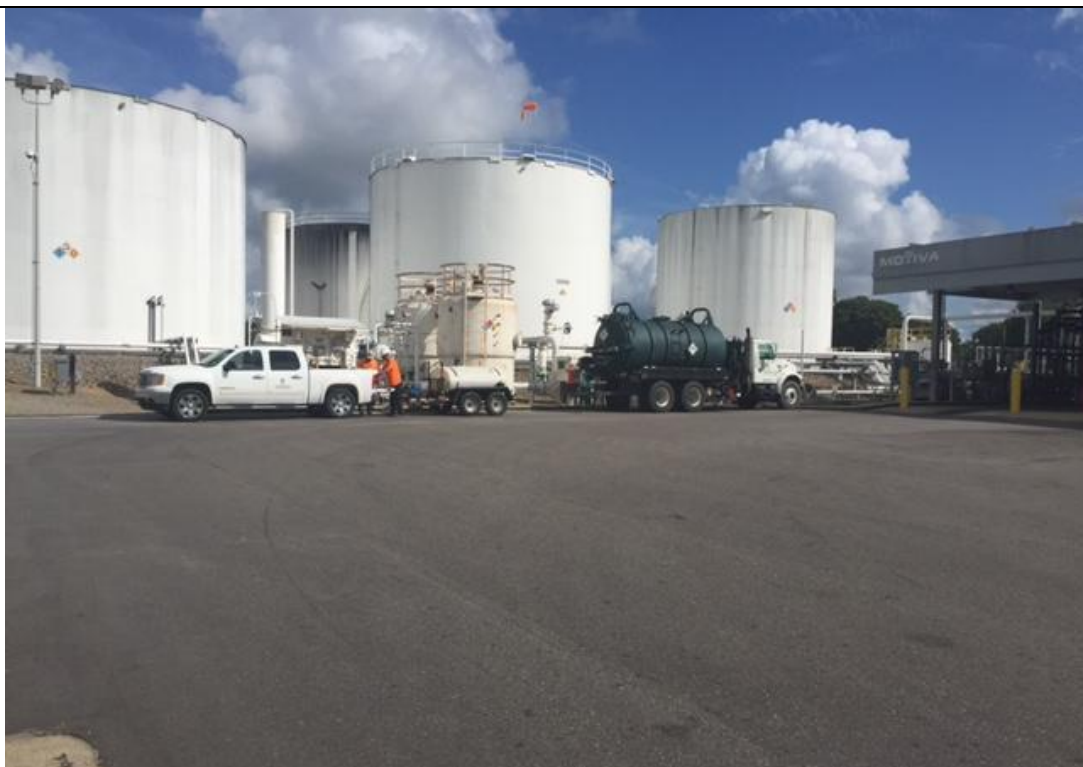
Photo No.
10

CCI preparing to clean tank for abandonment in-place.

On August 11, 2016, prior to abandonment in-place, the UST was thoroughly pressure washed and a vacuum truck was used to remove residual liquids contained in the UST. The UST was then monitored for vapors using an explosimeter that measures the lower explosive limit (LEL) of the vapors and percentage of oxygen. The local fire marshal instructed CCI that their presence was not required during the monitoring of UST vapors and UST closure activities.

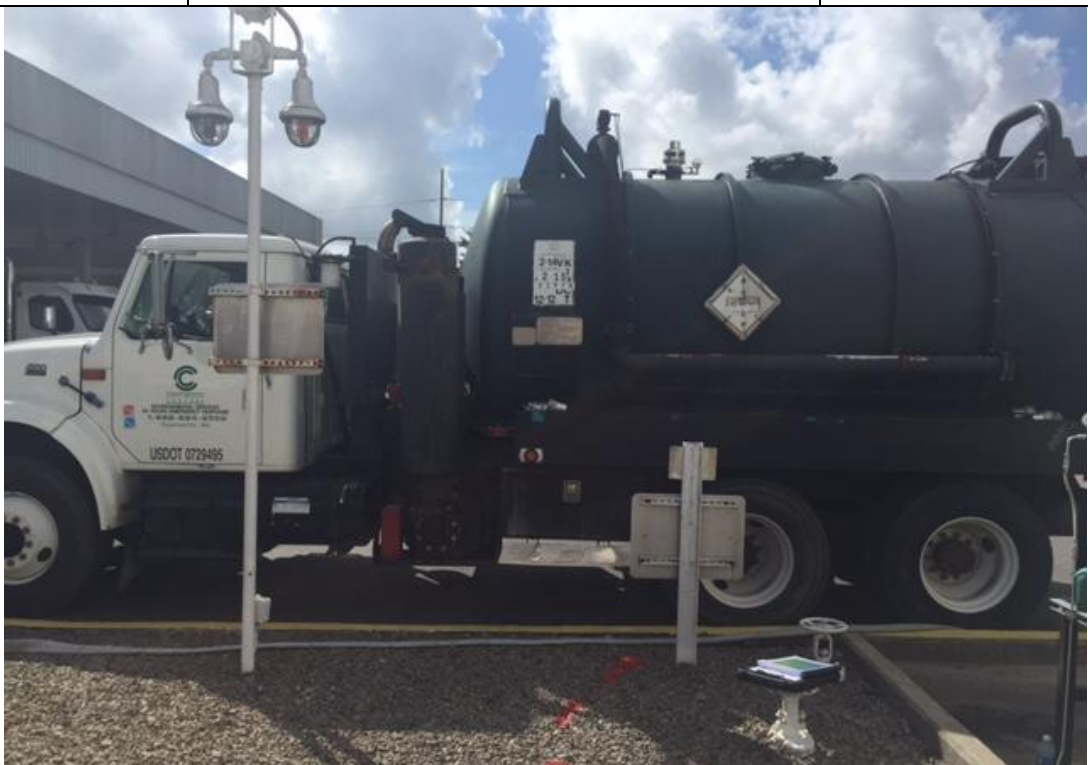
Direction Photo Taken: Southeast			
Description: Vacuum truck used for removing residual liquid from UST prior to in-place abandonment.

Rinsate and residual liquids pumped from the UST were disposed of in the facility's onsite oil-water separator system. The amount of liquid removed was minimal.

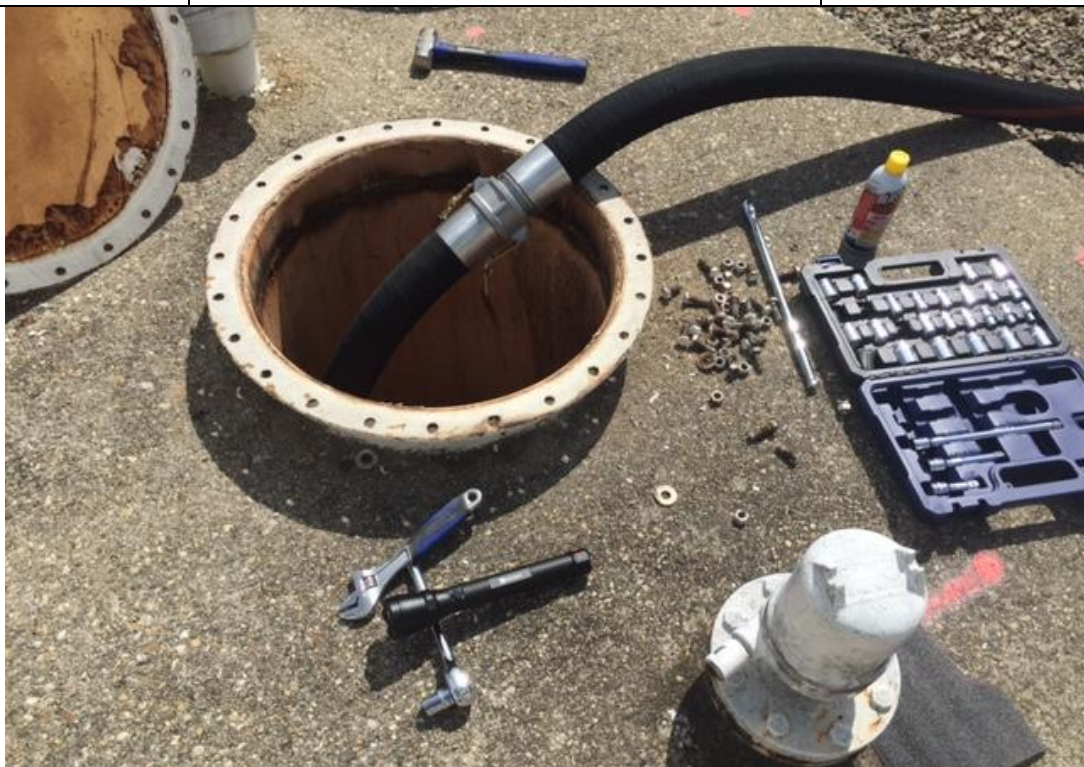
Vacuum truck hose in 24-inch manhole tank access.

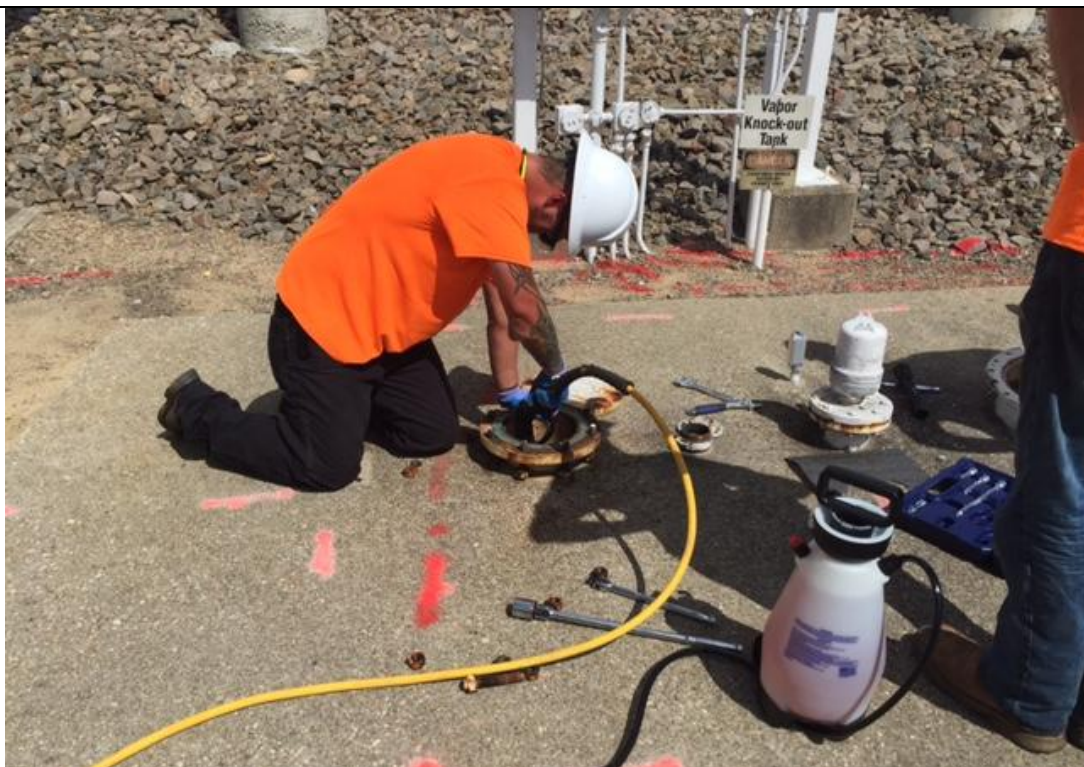
Photo No.
14

Pressure washing UST via measuring port.

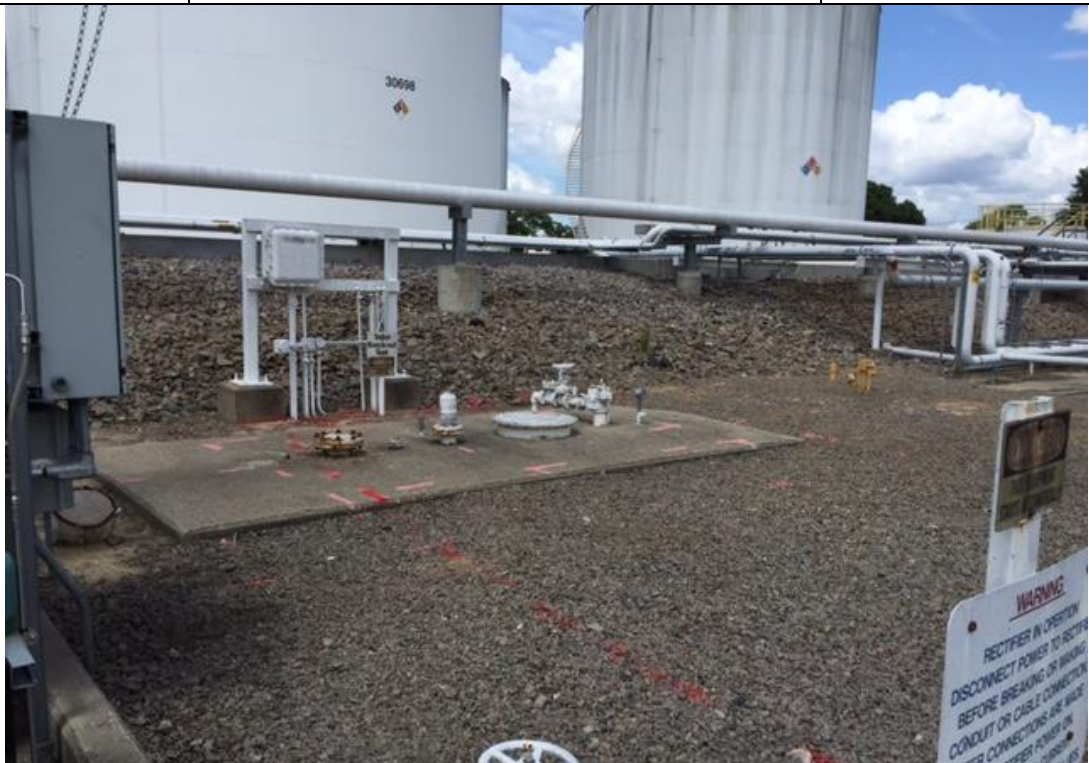
Direction Photo Taken: Northwest			
Description: Vapor knockout UST following abandonment in-place.

After the UST had been rinsed and liquids were removed, non-expanding foam was pumped into the UST. The UST was filled from the bottom up using an injection-type nozzle with an extension to reach all the way into the UST. The southwest half of the UST was filled first through the 2.5-inch measuring port and the northeastern half of the UST was filled via the 24-inch manhole. Both UST access points were filled completely so that the foam surface was flush with the opening. All gaskets, covers, and bolts were replaced on UST openings following foam placement. The concrete pad covering the UST was unaffected by UST abandonment activities. The gravel surface around the UST area was smoothed to original condition.
